LAKE COUNTY, ILLINOIS

2013 NORTH TOWER LAKE SUMMARY REPORT

PREPARED BY THE
LAKE COUNTY HEALTH DEPARTMENT
Population Health Environmental Services

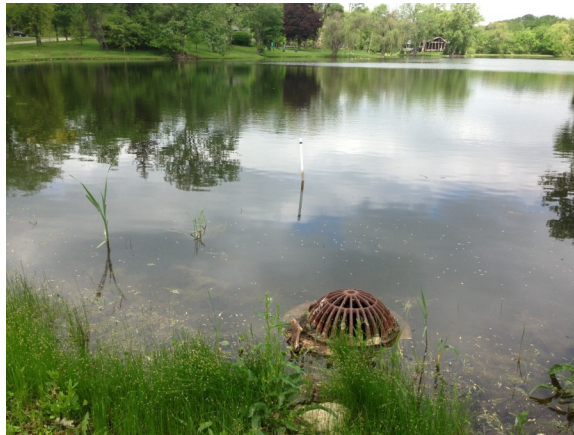
Outlet at North Tower Lake, 2013.

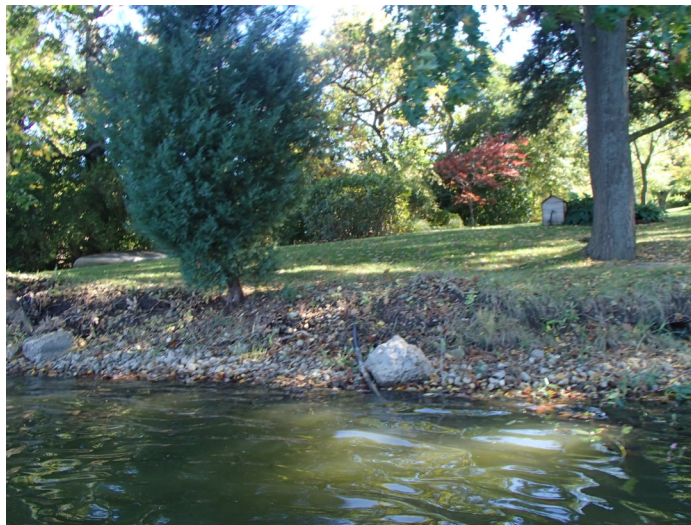
The monthly Secchi depths in 2013 ranged from 2.75 feet in July to 6.25 feet in September (Figure 1). Algal blooms were likely the cause of the decreased water clarity. Filamentous blooms were observed by the LCHD-ES throughout the entire monitoring season, and noted as mainly colonizing the shoreline and outlet areas of the lake.

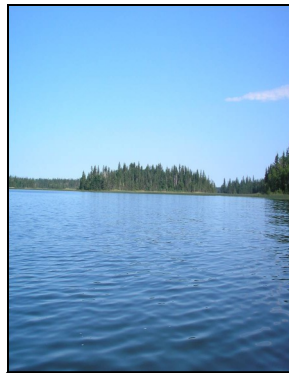
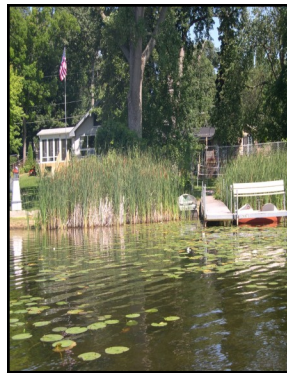
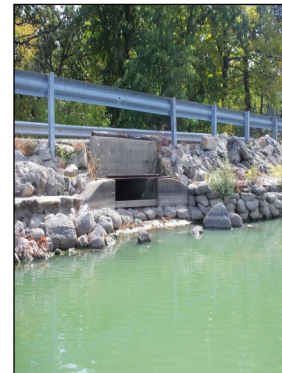
Figure 4. Trophic states illustrated.

OLIGOTROPHIC:

Lakes are generally clear, deep and free of weeds or large algae blooms. Though beautiful, they are low in nutrients and do not support large fish populations.

MESOTROPHIC:

Lakes lie between the oligotrophic and eutrophic stages. Devoid of oxygen in late summer, their hypolimnion limit cold water fish and cause phosphorus cycling from sediments.

EUTROPHIC: Lakes are high in nutrients, they are usually either weedy or subject to frequent algae blooms, or both. Eutrophic lakes often support large fish populations, but are also susceptible to oxygen depletion.

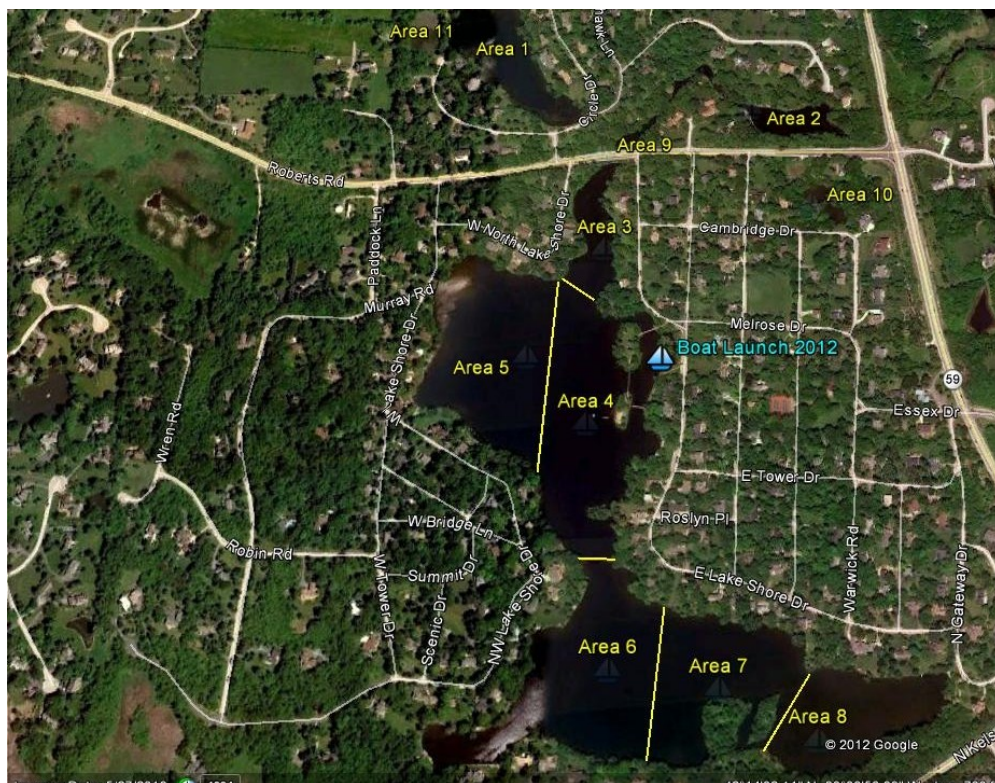
Figure 8. Treatment area map for the Tower Lakes, 2013.

Like Tower Lake, North Tower Lake is a heavily managed lake. The Tower Lakes are broken down into eleven management units; Unit 1 is North Tower Lake (Figure 6). Rollins Aquatic Solutions, Inc., surveyed and treated the lake for aquatic vegetation and/or algae on three different occasions during the season, May - September. In May the focus of treatments was Curlyleaf Pondweed, filamentous algae and Sago Pondweed. They were treated with an Algicide; Aquathol K, which is an endothall liquid used to treat a broad range of aquatic plants, and Tribune, a diquat bromide used to treat pondweeds. It was treated a second time in late June for Chara, filamentous algae and Phragmites using copper sulfate and finally in August for Sago Pondweed and filamentous algae using diquat and copper sulfate.

The LCHD-ES recommends that the TLIA consider only treating for Curlyleaf Pondweed, unless Eurasian Water Milfoil appears at sometime in the future. Allowing for expansion of native plants such as Sago and Small Pondweed will help to alleviate the need for treatment of algae on the lake as plants will compete for nutrients against algae, hence suppressing their populations. LCHD-ES supports the chemical management of the non-native and invasive species, Common Reed Grass (*Phragmites* spp.).

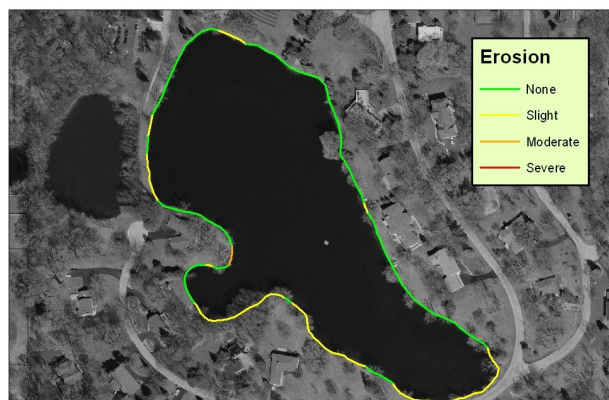
Figure 9. Shoreline erosion assessed on North Tower Lake, 2013.

In 2013, 41% percent of the 0.55 mile shoreline was experiencing some degree of erosion (Figure 7). Although the amount of eroding shoreline has decreased since 2007 when 96% of the shoreline exhibited some degree of erosion; there was approximately 45 feet of shoreline discovered in 2013 that had increased in severity from having slight to moderate erosion occurring upon it. Remediation of some areas previously documented with slight erosion explains the decrease in overall erosion on North Tower Lake. In 2013, only 39% of the shoreline was considered slightly eroded and an additional 2% exhibited moderate erosion. Some of the shoreline that was documented as being slightly eroded remained unchanged from 2007. It is recommended that homeowners implement controls soon as it is easier to remedy slightly eroded shorelines. There are several alternatives available, but native plantings can provide sufficient erosion control due to the plants having deep root systems, they also have an added benefits such as nutrient removal and habitat for native fauna. In areas with moderate erosion there may be a need to combine hard-scaping and native plantings in order to be effective.

Table 3. Degree of erosion on North Tower, 2013		
Erosion	Miles	Percent
None	0.32	59%
Slight	0.22	39%
Moderate	0.01	2%
Severe	0.00	0%
